Mikko Ortamala
21.10.2020

River Loviisanjoki Renovation

Renovation processes in Finland

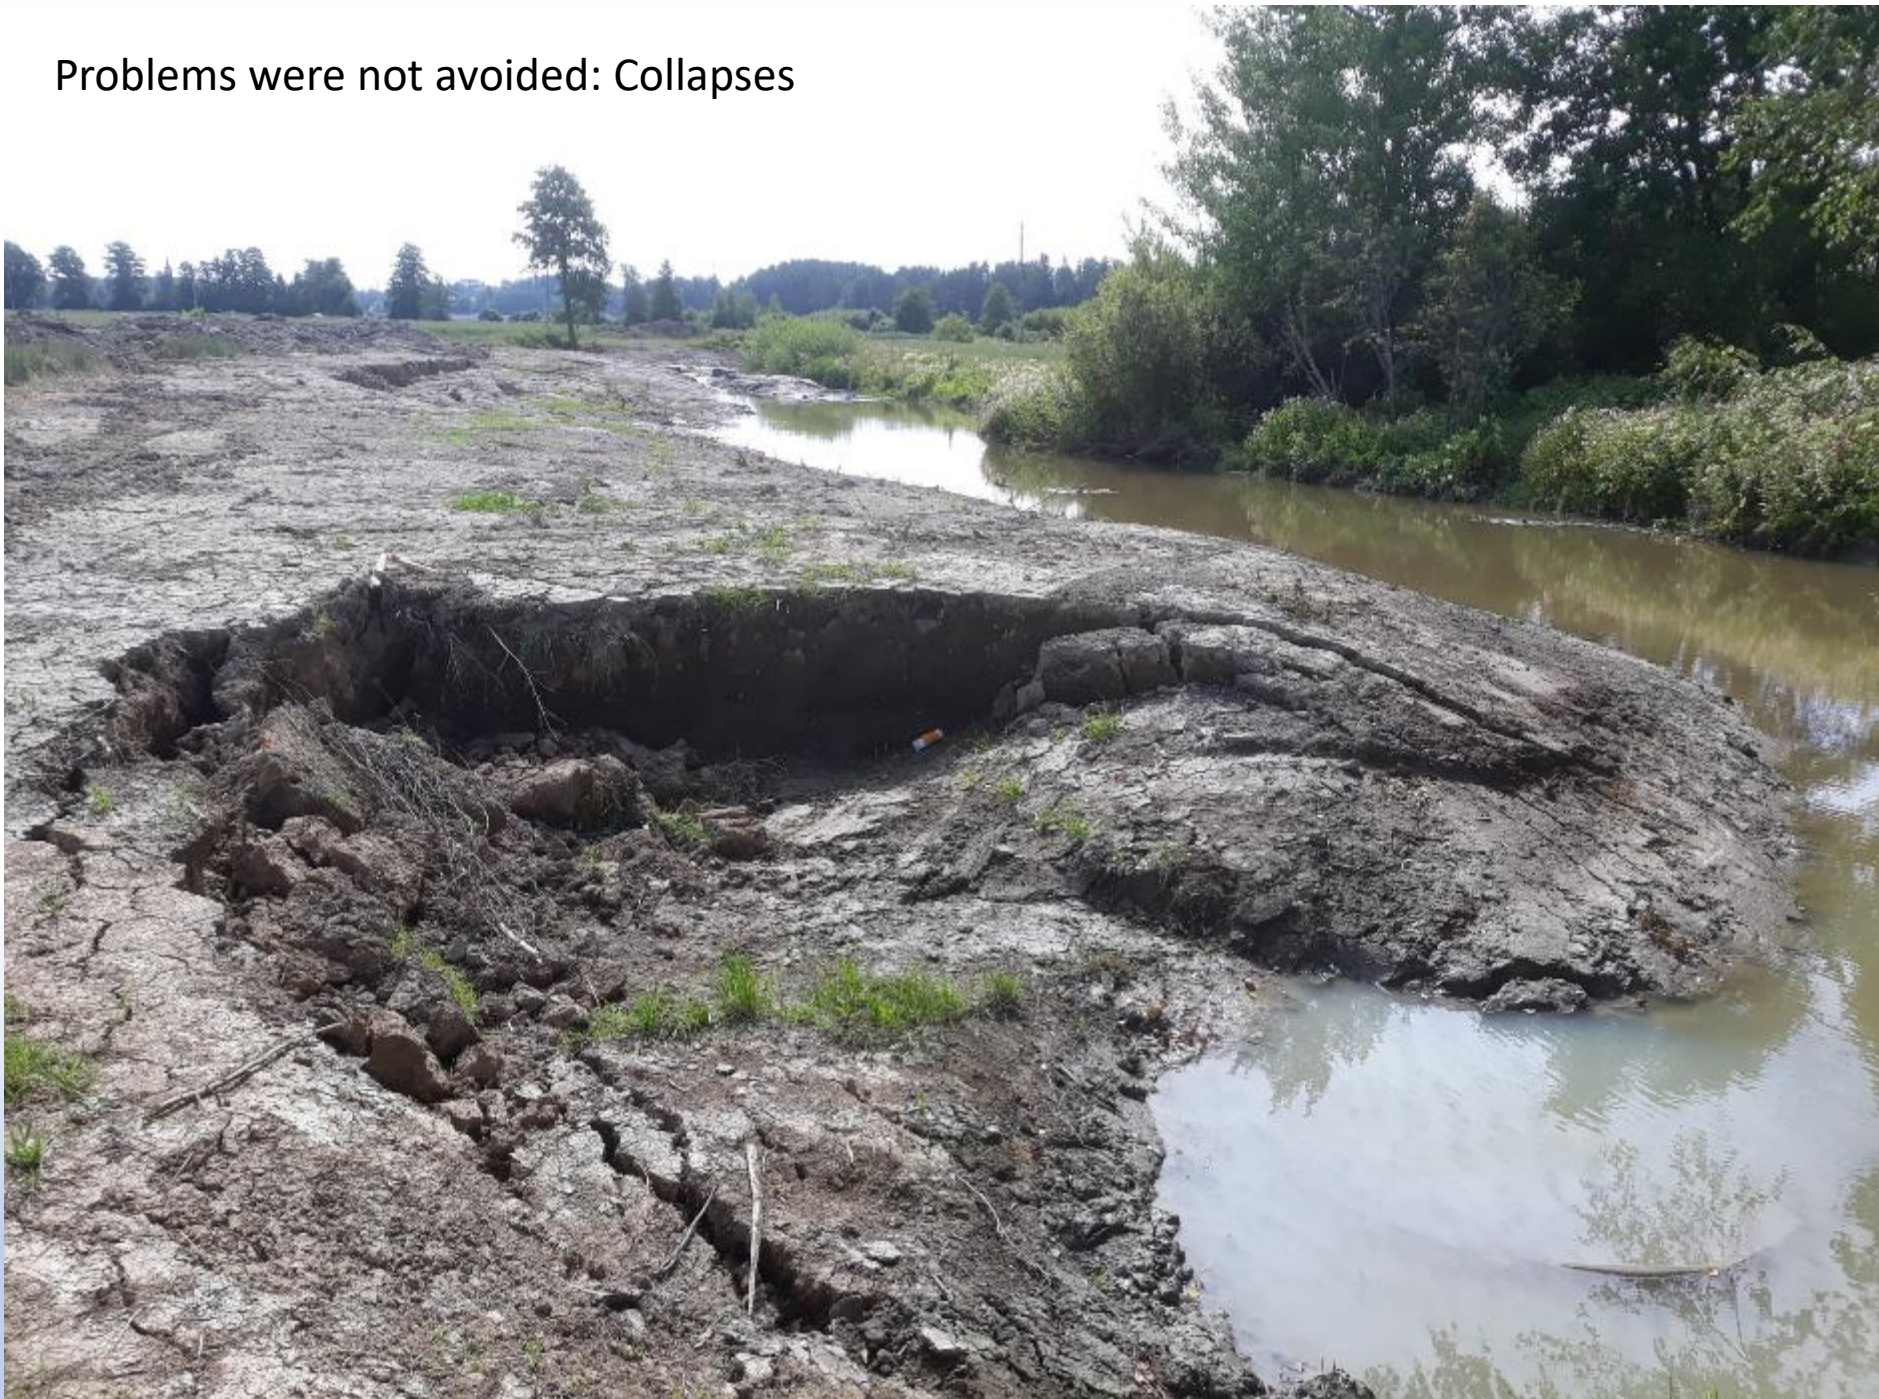
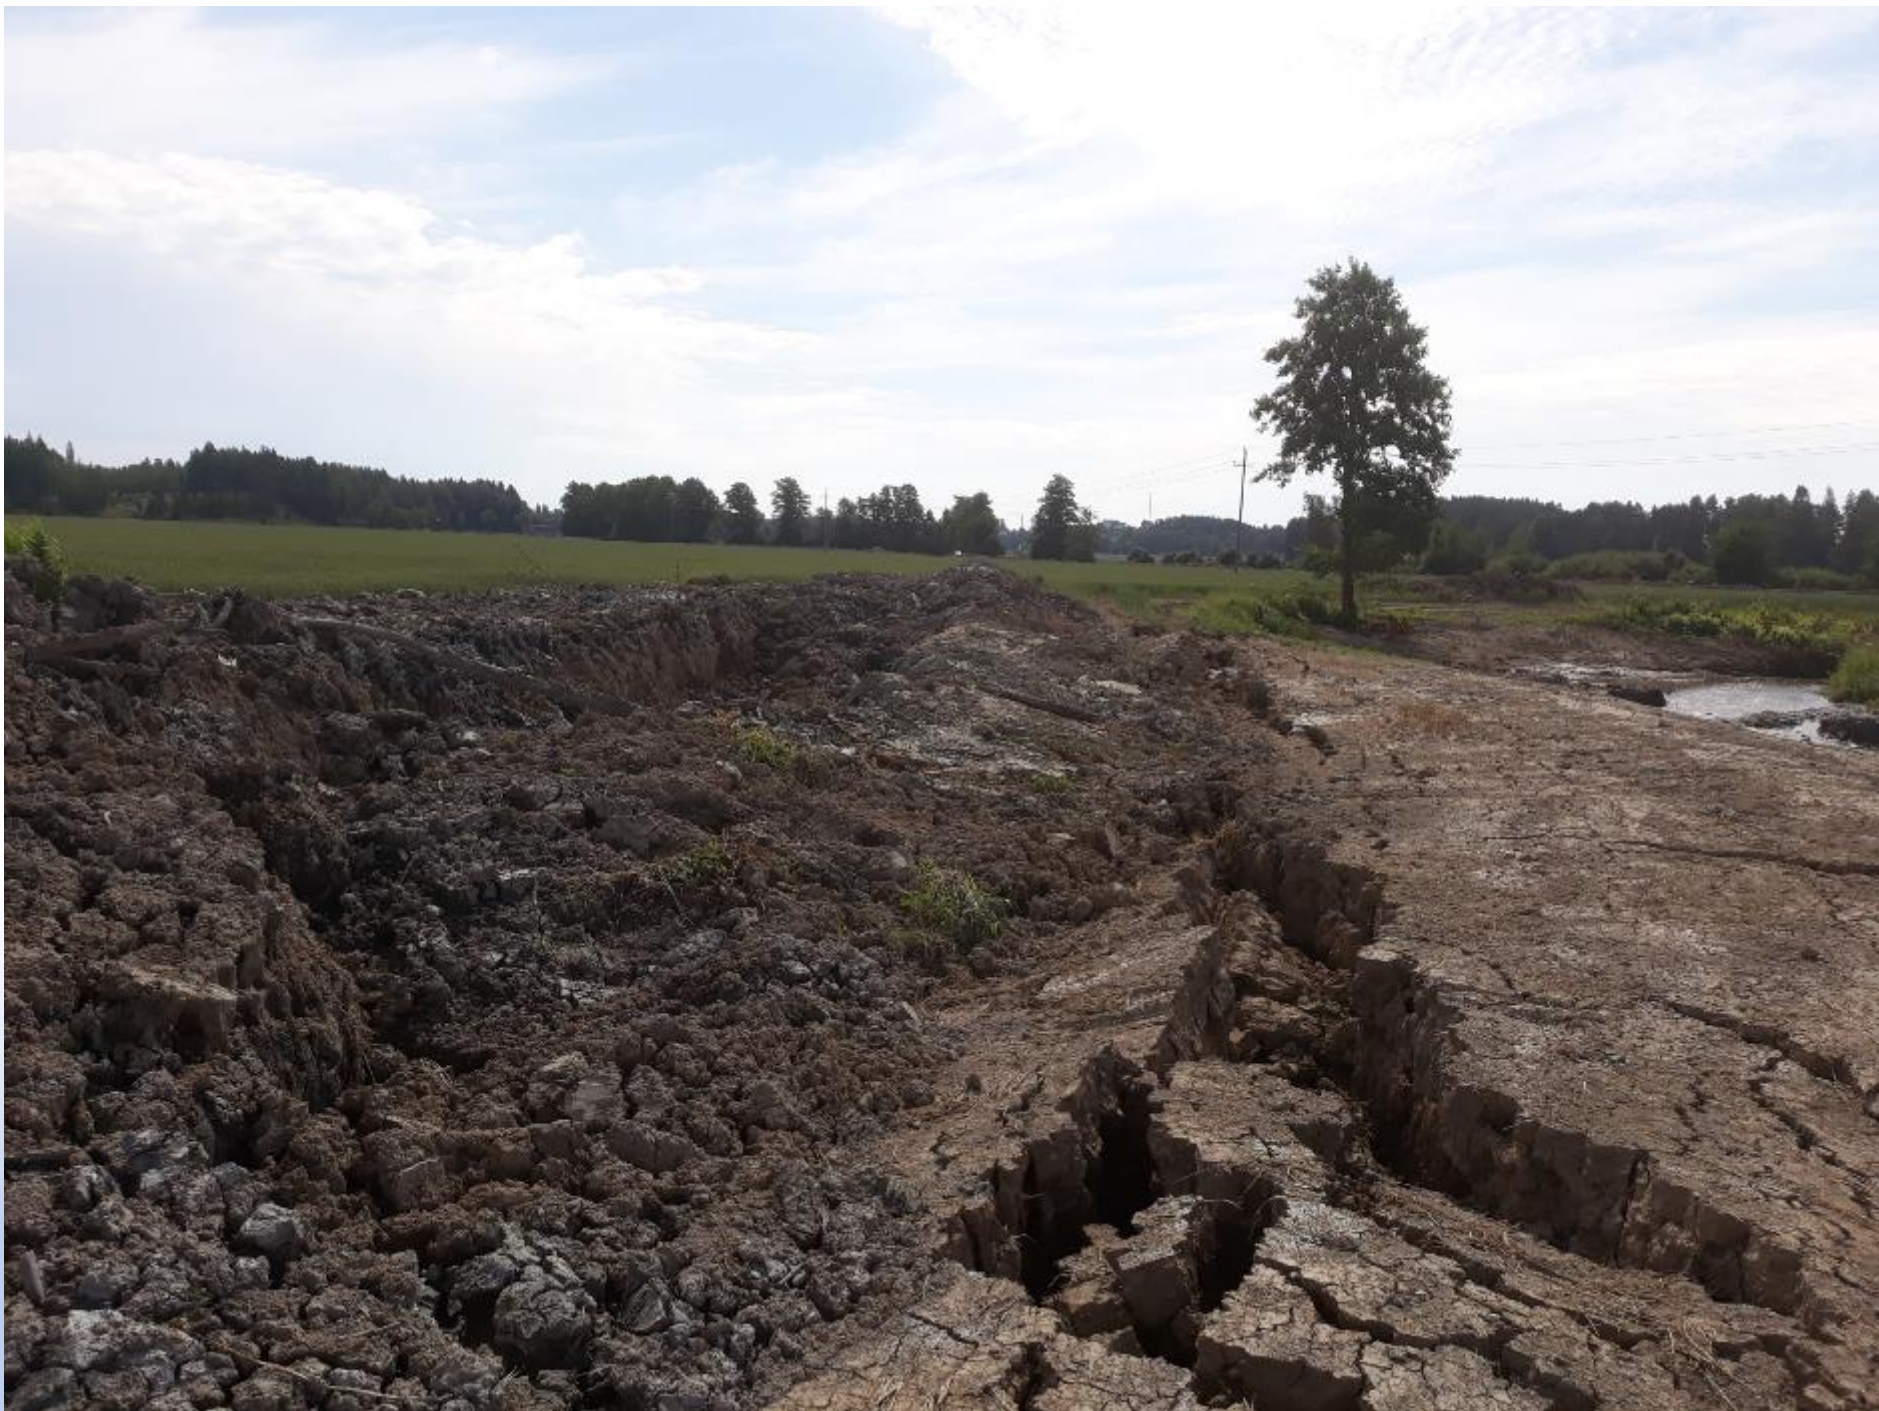
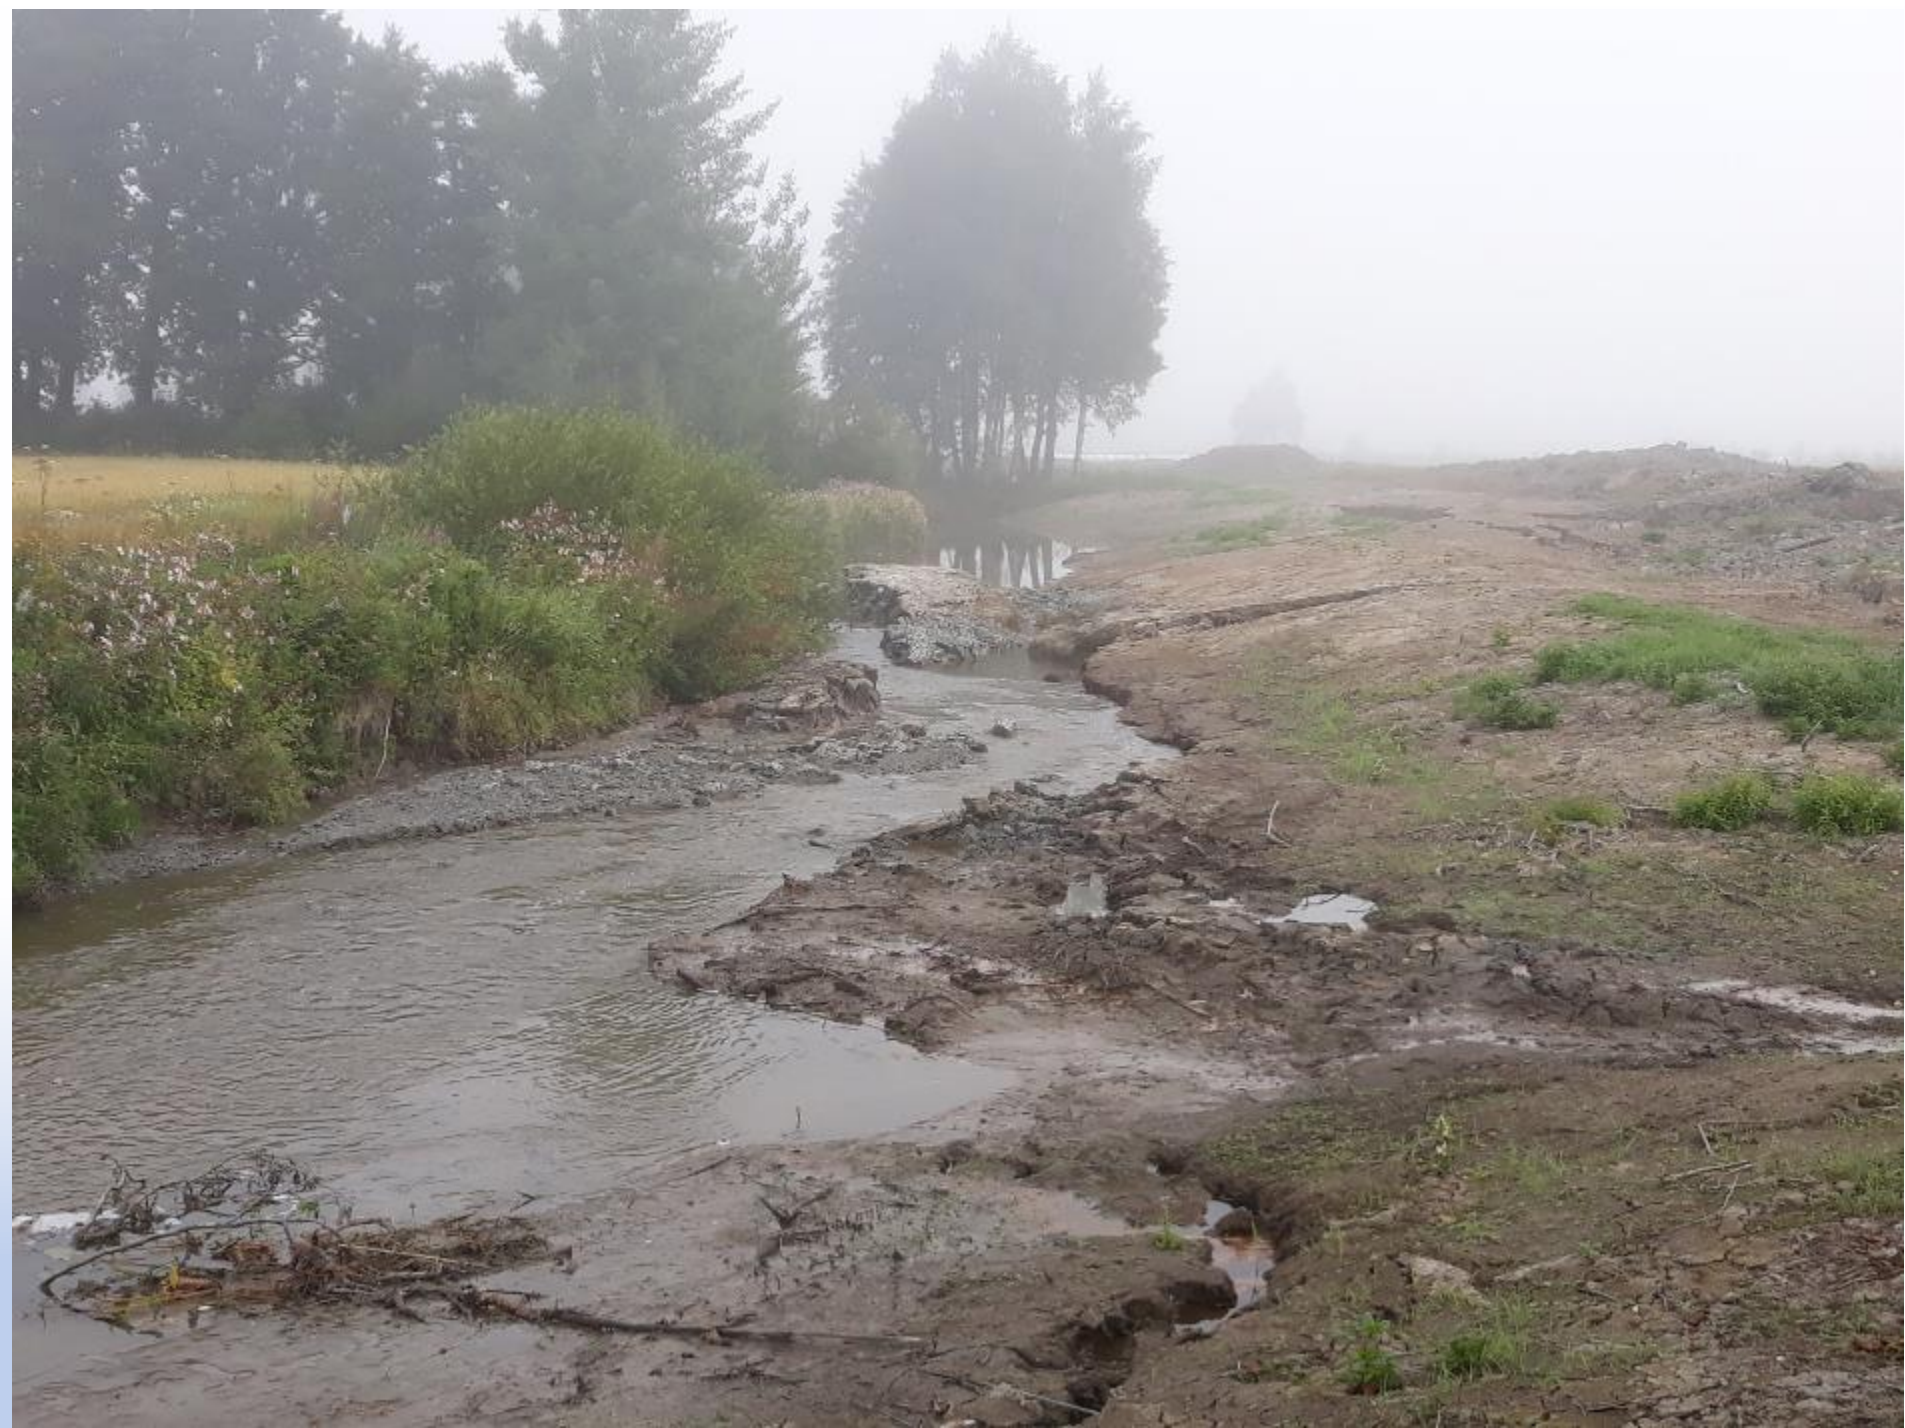
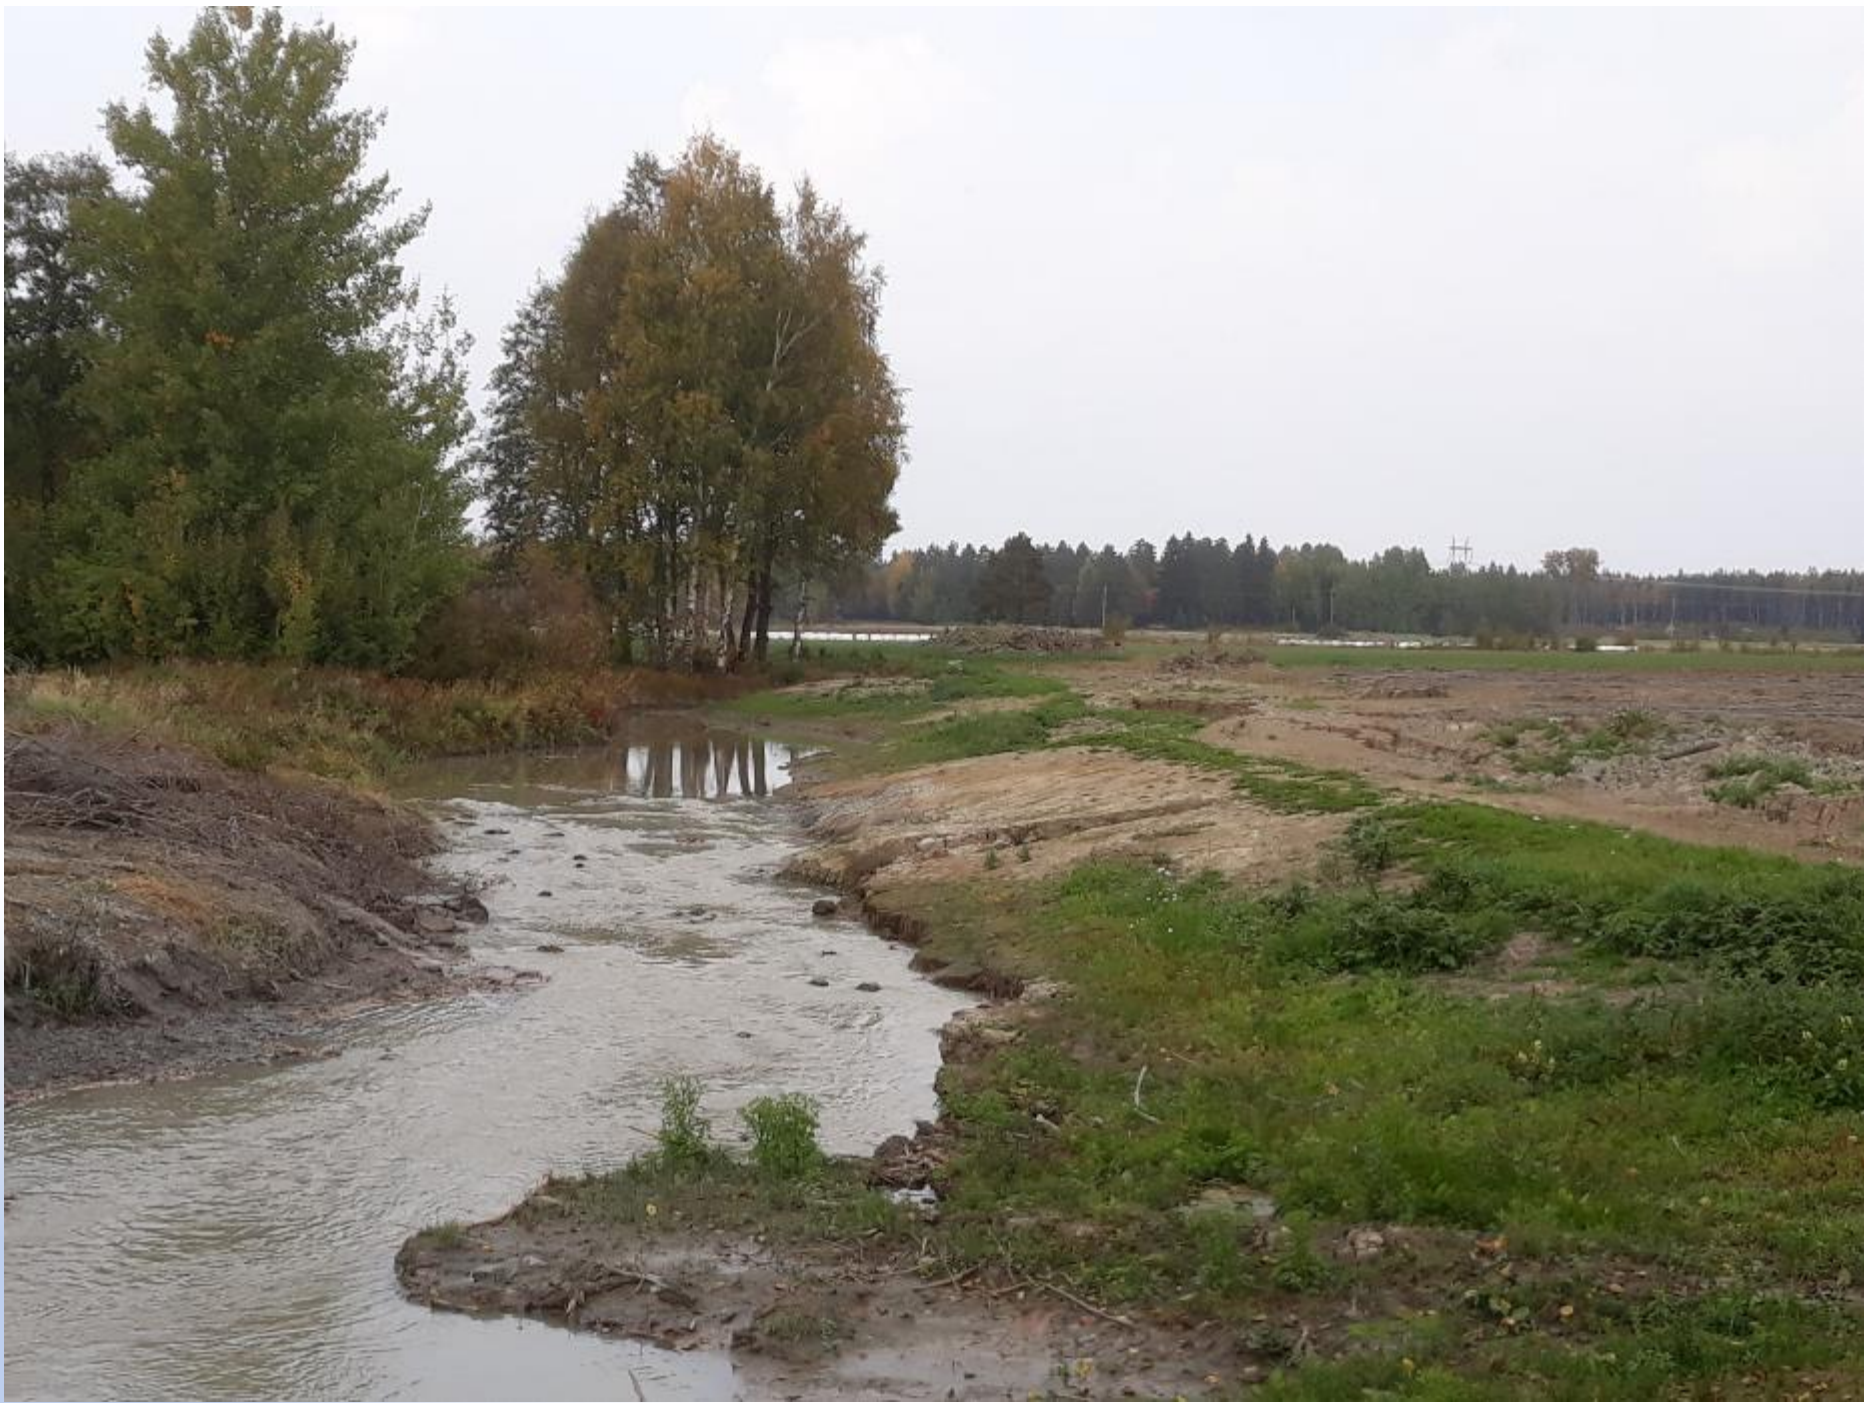
Problems were not avoided: Collapses

- Soil type. The clay on downstream is partly very loose and muddy.
- Landfilling too close to slope caused pressure when trying to avoid crop losses
- Decrease of back pressure in the slope (30cm low-flow channel)
- Decrease of vegetation and root binding in slope (1:2!)
- Groundwater surveys have been carried out, but water is discharged from the slope
- Excavation of wet floodplains / risk of collapse / outflow from excavated floodplains during the overflow period before vegetation
- Low-flow channel fills with sediment during excavation, causes outflow
