SUCCESS STORY

The renovation of the Sodite stream at Jelgava Local municipality

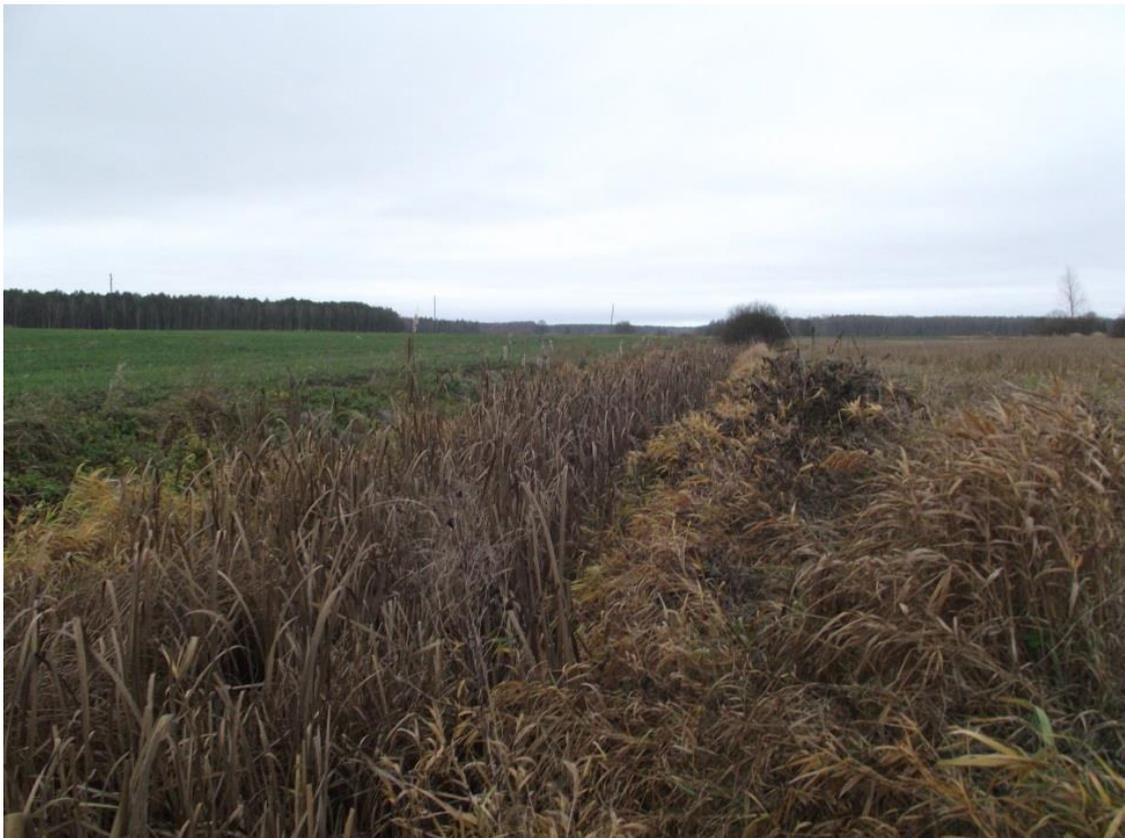
Figure 2. The Sodite stream before renovation (12.11.2015)

The main idea of the project for this pilot site was to renovate the Sodite stream in a full length of 3.75 km and transform the cross section of this stream from traditional trapezoidal into two-stage ditch for the first time in such a length in Latvia. Wooden support walls and straw covers were used to prevent erosion of the main channel and flood plain benches. In addition, two monitoring wells were installed for water quality monitoring activities during the project lifetime.

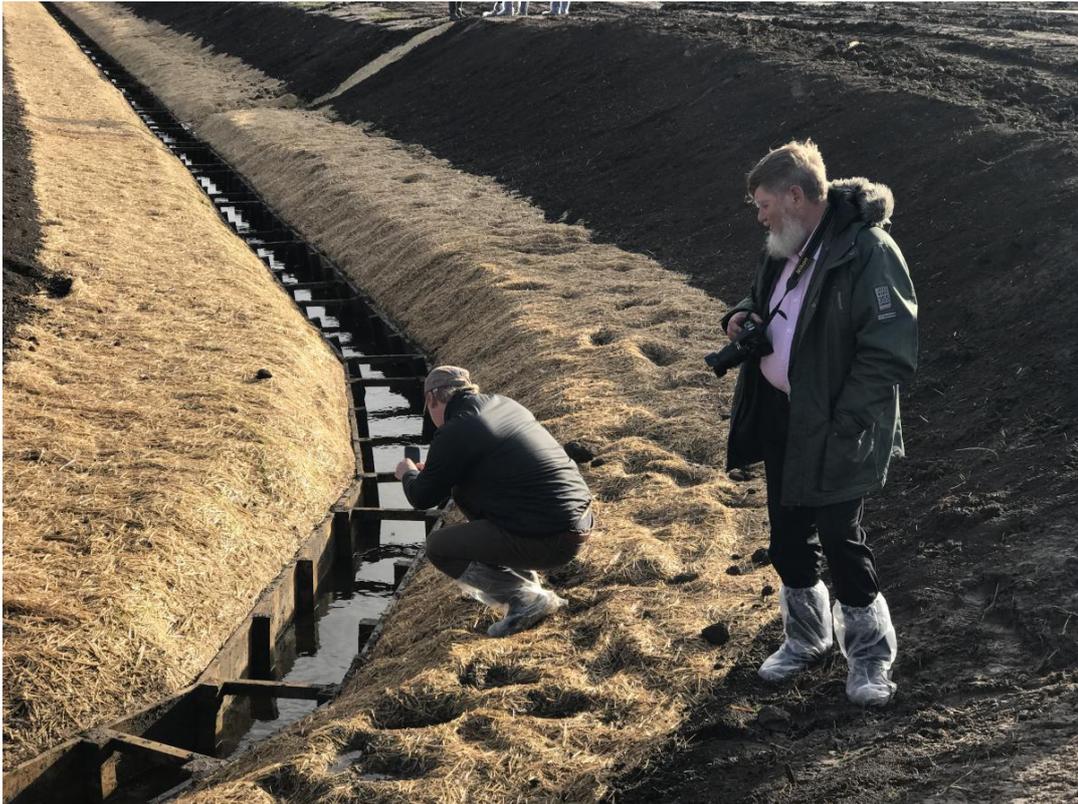
Figure 3. The Sodite stream after renovation (14.11.2017)

After the renovation of the Sodite stream the landowners in the catchment area can start to renovate their subsurface tile drainage systems as the main ditch in its current condition is ready to convey water downstream properly. That is the reason why landowners are very satisfied with the project activities. The NUTRINFLOW project allowed the Jelgava Local municipality to involve stakeholders in practical actions to improve their drainage systems. Through practical examples the project provided an insight into how two-stage ditches can be implemented in the rural landscape of the Jelgava Local municipality and elsewhere.

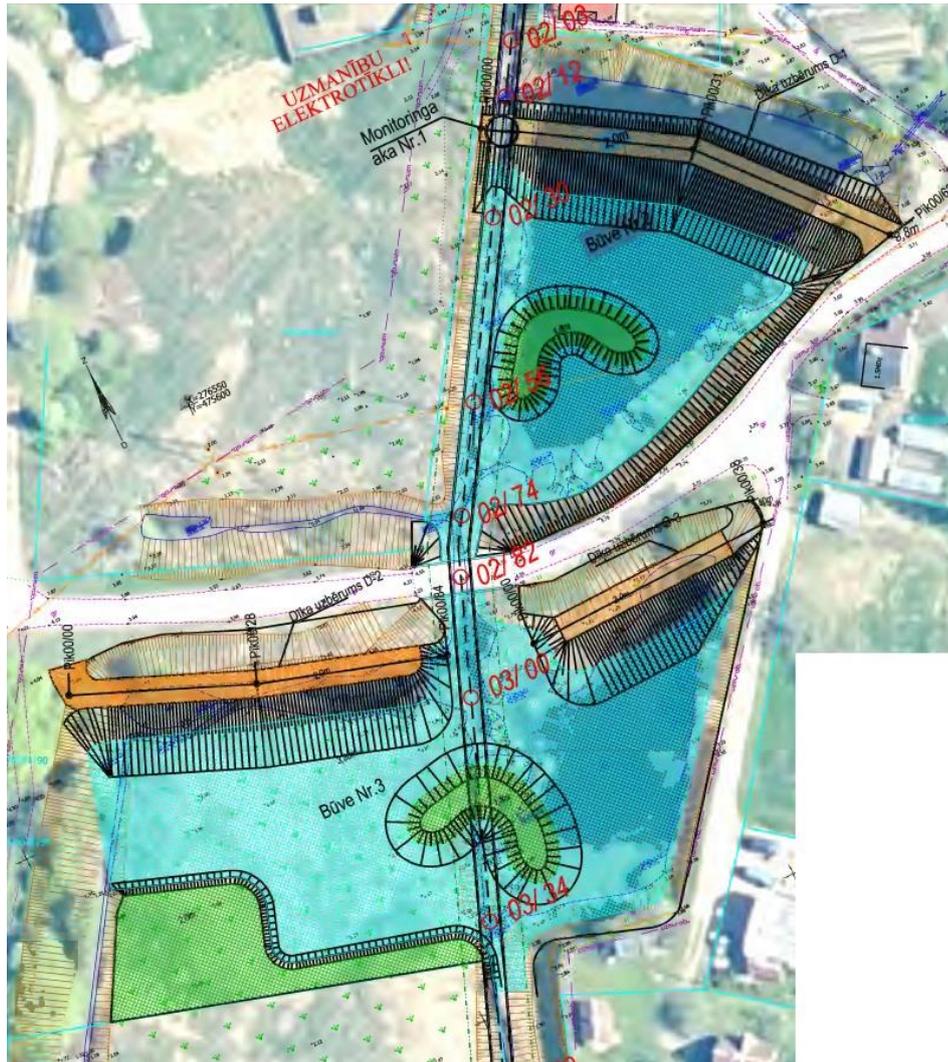
Figure 4. A schematic drawing of the constructed wetland in the downstream part of the Sodite stream

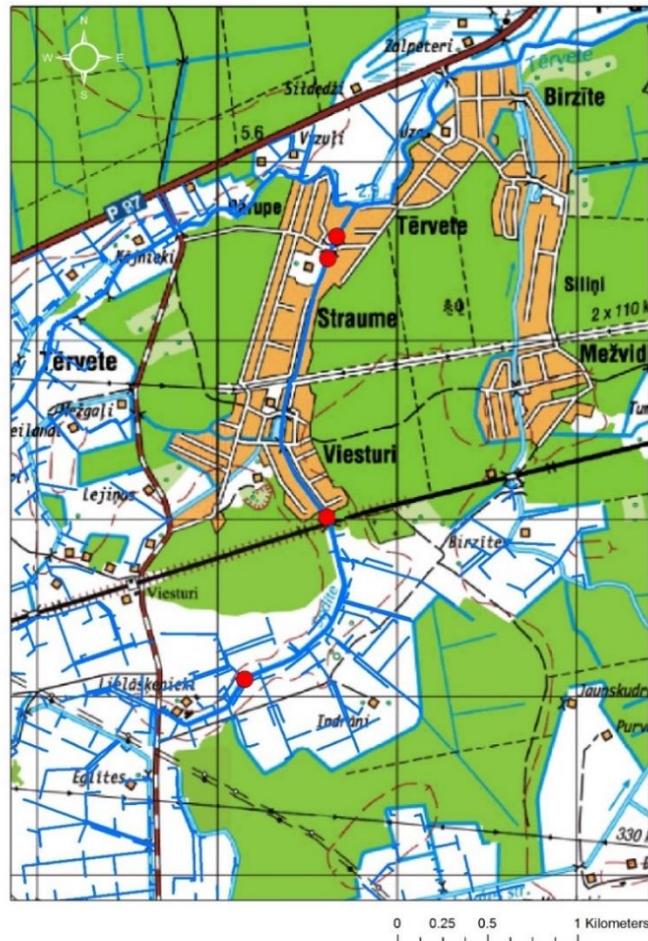
- Water sampling sites
- The Sodite stream
- Drain collectors

Figure 5. The water sampling sites at the Sodite stream

Water samples were collected twice a month at:

- ❖ Subsurface drain collector (discharge from agricultural fields);
- ❖ Open ditch (discharge from agricultural lands);
- ❖ Before constructed wetland (CW);
- ❖ After constructed wetland (CW).

Water samples were collected at the inlet and outlet of the constructed wetland and at drain collector, open ditch using a manual grab sampling approach. Water samples were analyzed for nitrate-nitrogen ($\text{NO}_3\text{-N}$), ammonium-nitrogen ($\text{NH}_4\text{-N}$), total nitrogen (TN),
